ASSESSMENT, REHABILITATION AND REPLACEMENT OF THREE LARGE DIAMETER FEEDERMAINS IN THE CITY OF OTTAWA

**Adrien Comeau, M.Eng. P.Eng. – Stantec Consulting Ltd.
400-1505 Laperierre Avenue
Ottawa, Ontario
K1Z 7T1**

**Derek Potvin, P.Eng. – Robinson Consultants Inc.
100-350 Palladium Drive
Kanata, Ontario
K2V 1A8**

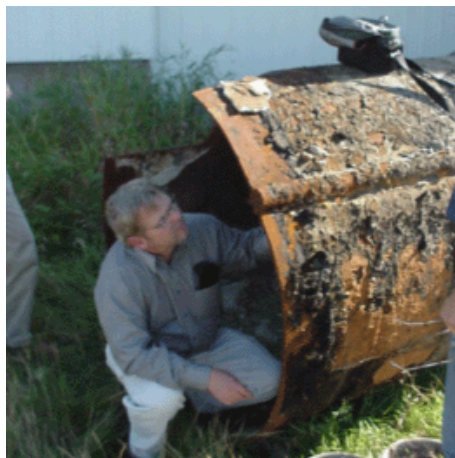
FIGURE 3: 'A' LINE SAMPLE AT BRONSON AVENUE

A section of 'A' line was salvaged as part of a previous contract that required a connection to this line. The sample is shown in **Figure 3** and was located in non-contaminated and well drained soils which is not the case for a significant portion of the 'A', 'B' and 'C' Lines. Given that the trench conditions from where the sample was removed are considered to have a low corrosion potential, a much higher level of corrosion is expected to have occurred at other locations along the main. The pipe sample was therefore considered to represent a best case scenario for the overall condition of the pipe. A visual inspection of the pipe sample was completed and the results are generally described as follows:

- The pipe appeared to have been originally wrapped in a bituminous impregnated burlap coating. Most of the coating was no longer present on the pipe sample;
- The exterior pipe wall had many corrosion pits including pits that appeared to be at least 50 % through the pipe wall;
- A number of the rivets showed corrosion damage;
- The cement lining was thinnest over the lock bar and the bar inside the pipe was significantly corroded. There appeared to be a tendency for the formation of longitudinal cracks in the lining on either side of the lock bar. This may have exposed the lock bar to corrosion;
- Some of the cement mortar lining was very soft and red in colour. This mortar appears to have been penetrated by corrosion products from the pipe. It is likely that this damage occurred while the pipe was in service; and;
- The exterior lock bar also showed signs of serious corrosion damage.

- Line 'B' is leaking. Given that Line 'A' was installed adjacent to and at the same time as Line 'B', it is also assumed to be leaking.
- An inspection of a sample of Line 'A' showed signs of lining delamination, interior corrosion, exterior corrosion pitting, corrosion of the rivets and serious corrosion of the lock bar.
- An investigation of the past land uses identified many sites along the existing watermain alignments with medium to high corrosion potential.
- A previous inspection of the pipe interior confirmed that the pipe was corroded where the in-situ applied cement mortar lining was missing.

This data indicated that the pipe had been subjected to interior and exterior corrosion. It was also confirmed that the lock bar was subjected to corrosion and that failure of the lock bar could lead to a rupture of the pipe.

In consideration of the above results combined with the factors listed in the problem definition section of this paper, it was clear that rehabilitation and/or replacement of the pipes was necessary. It was therefore concluded that no further condition assessment investigations were necessary and that alternatives for their upgrade needed to be investigated.
